**SHORELINE MANAGEMENT ACT
SUBSTANTIAL DEVELOPMENT PERMIT**

PROJECT: Holly Street Permanent Creekbank Repair

PERMIT NUMBER: SHO21-00018

REQUEST: The project will install bio-engineered creek bank stabilization along 130 feet of Issaquah Creek. The measures will include large woody debris and habitat structures anchored into the stream bank to provide erosion protection. The stream bank will be revegetated to provide long term stabilization.

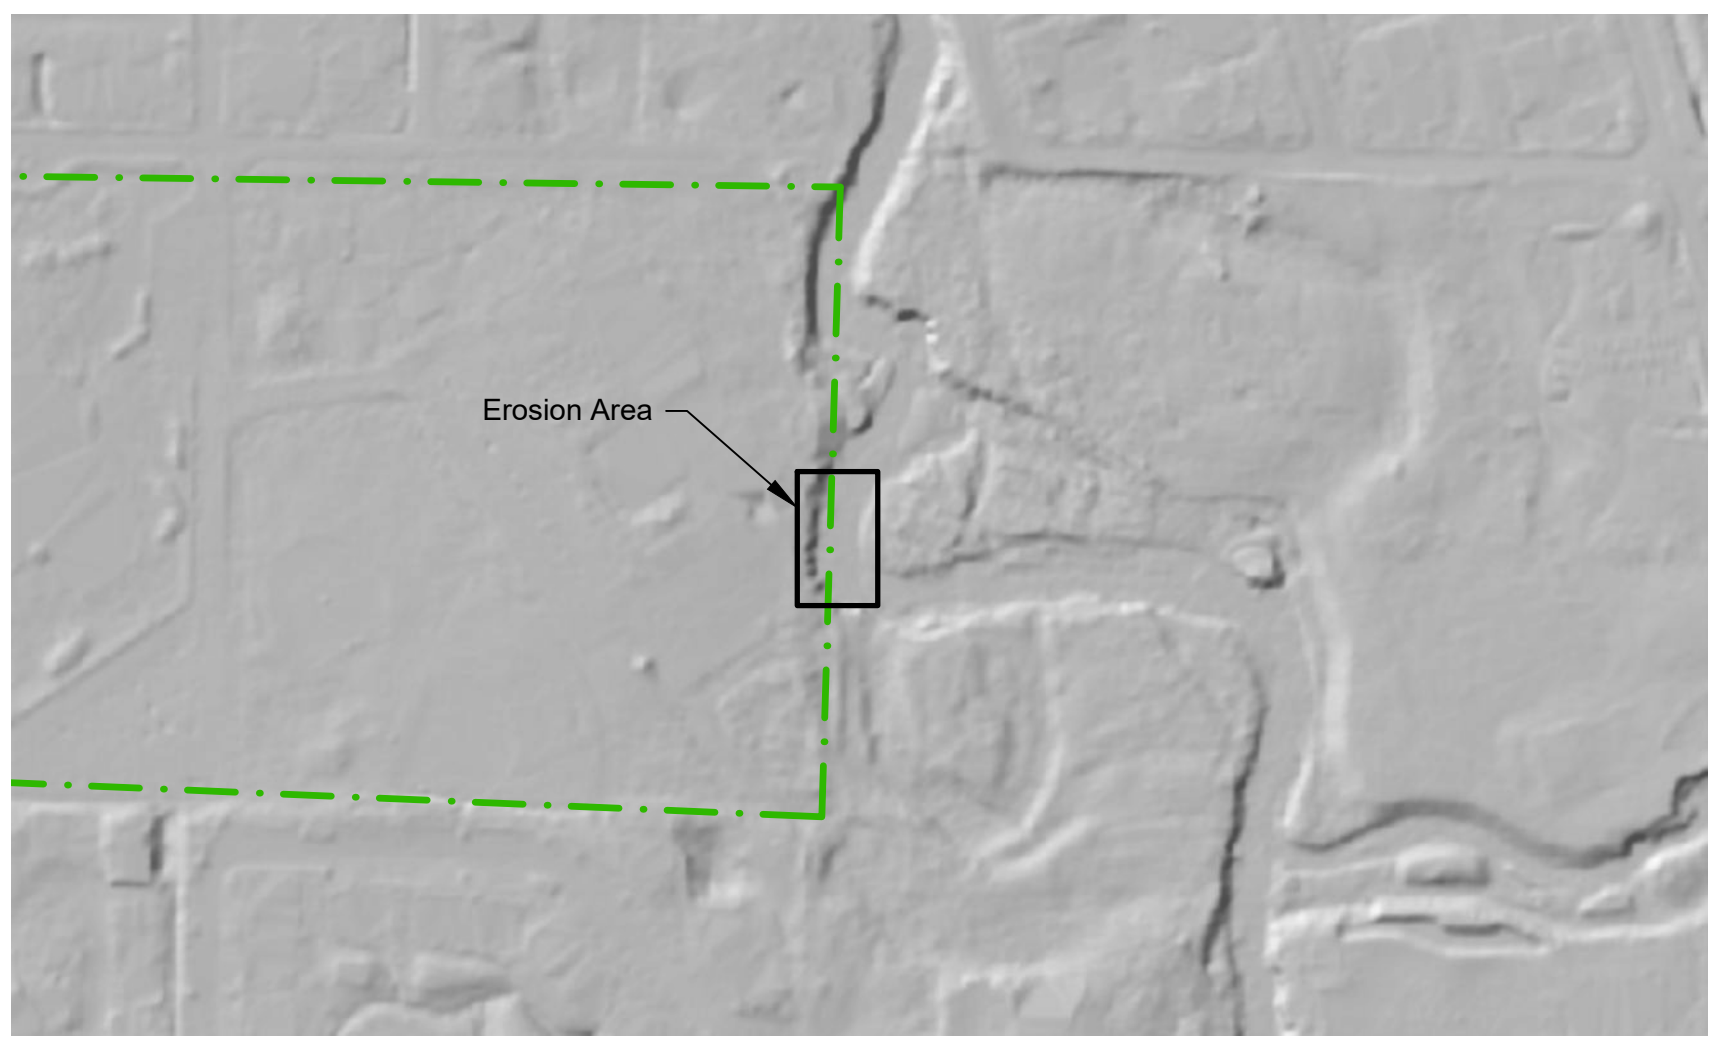
LiDAR Site Plan

Reference: Site plan based on field measurements, observations, and LiDAR map review.

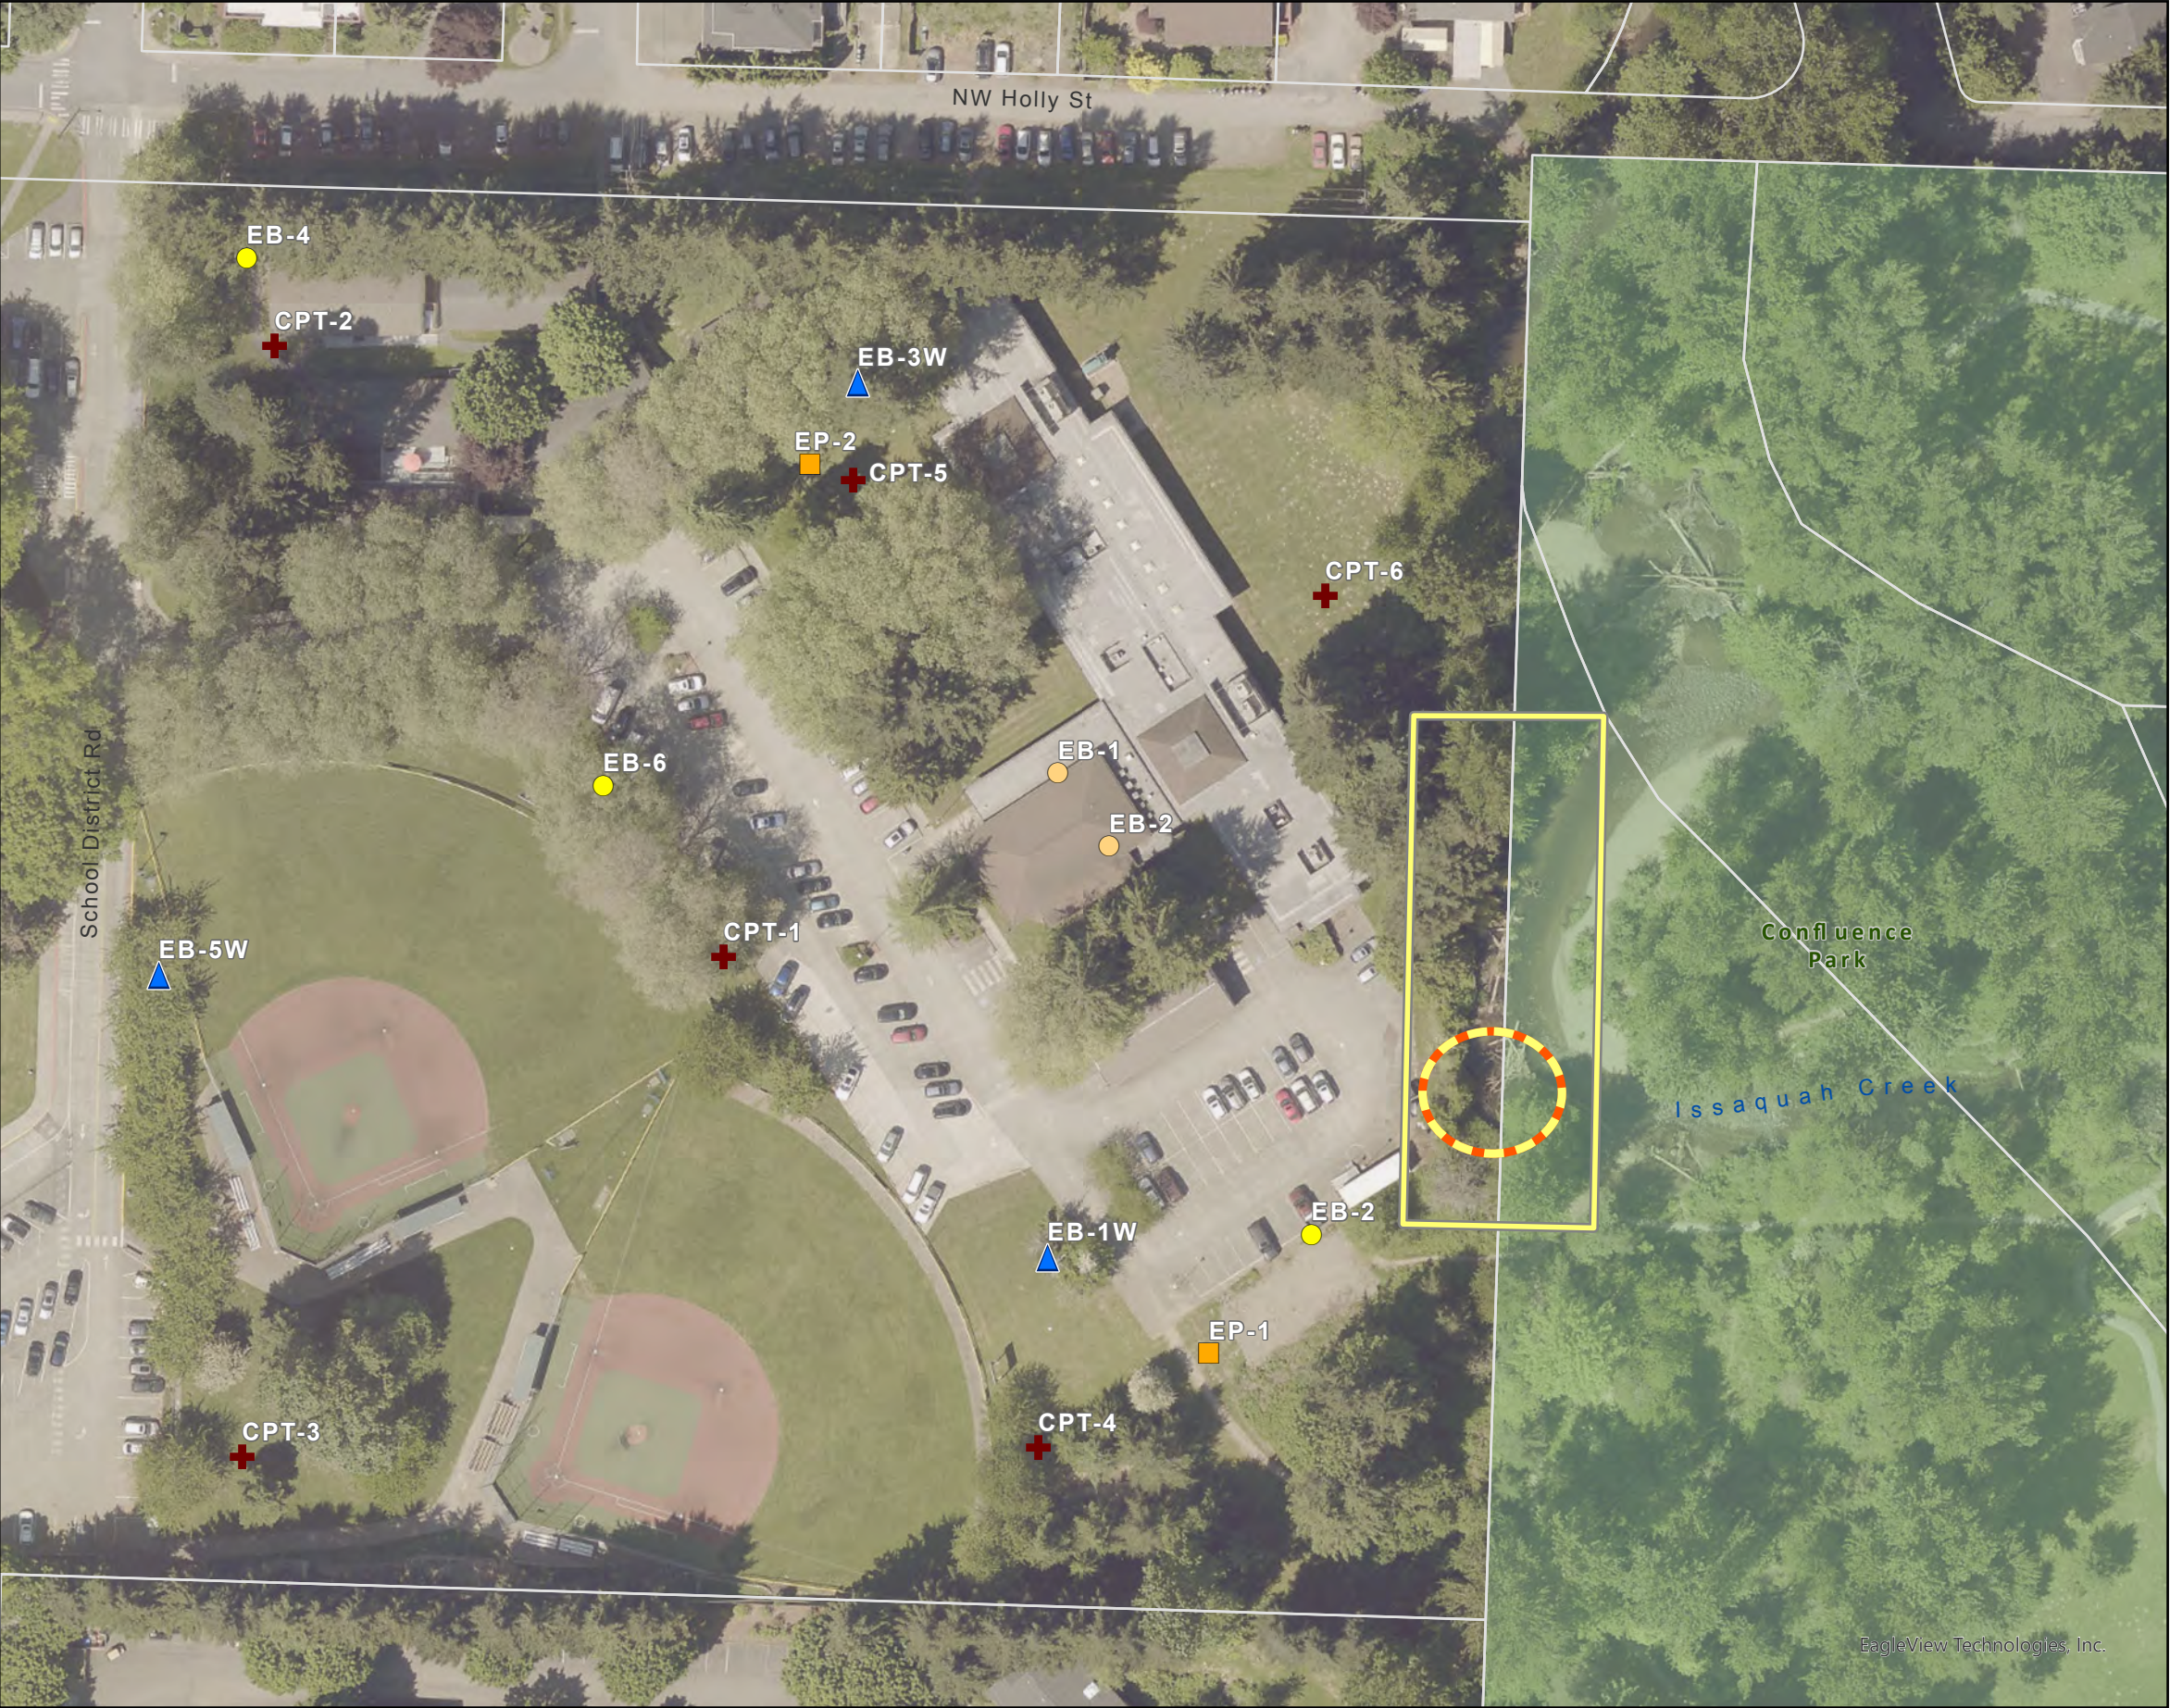
- APPROXIMATE AREA OF TEMPORARY EROSION REPAIR
- CREEK BANK EXPOSURE RESULTING FROM 2020 FLOODS
- EXPLORATION BORING (1999)
- EXPLORATION BORING (2018)
- EXPLORATION PIT (2017)
- MONITORING WELL (2018)
- CONE PENETROMETER (2018)
- PARCEL

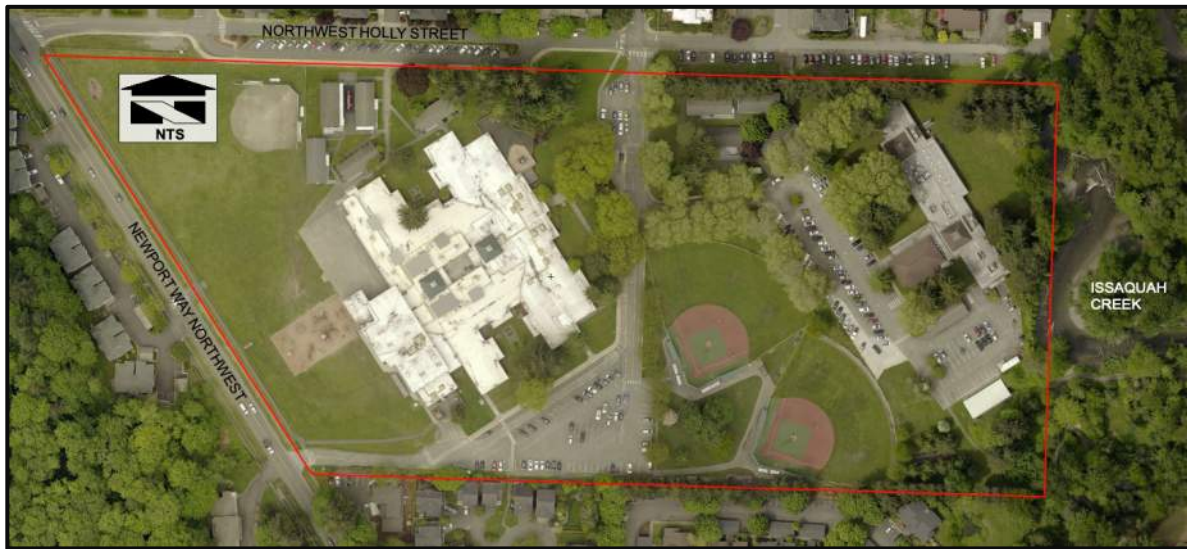
Figure 4 - Aerial view of subject property.

Topography on the site is relatively flat with a slight slope to the east toward Issaquah Creek. Adjacent to the stream, topography drops steeply to the east. The majority of the property is developed with buildings and fields and has limited native vegetation. However, a few portions of the site contain forested areas with shrubs and groundcover in the understory. The forested areas along the northern and eastern edges of the property are primarily vegetated with native species, with some Himalayan blackberry and other invasive species along the eastern side of the property. Confluence Park is located to the east of the subject site.

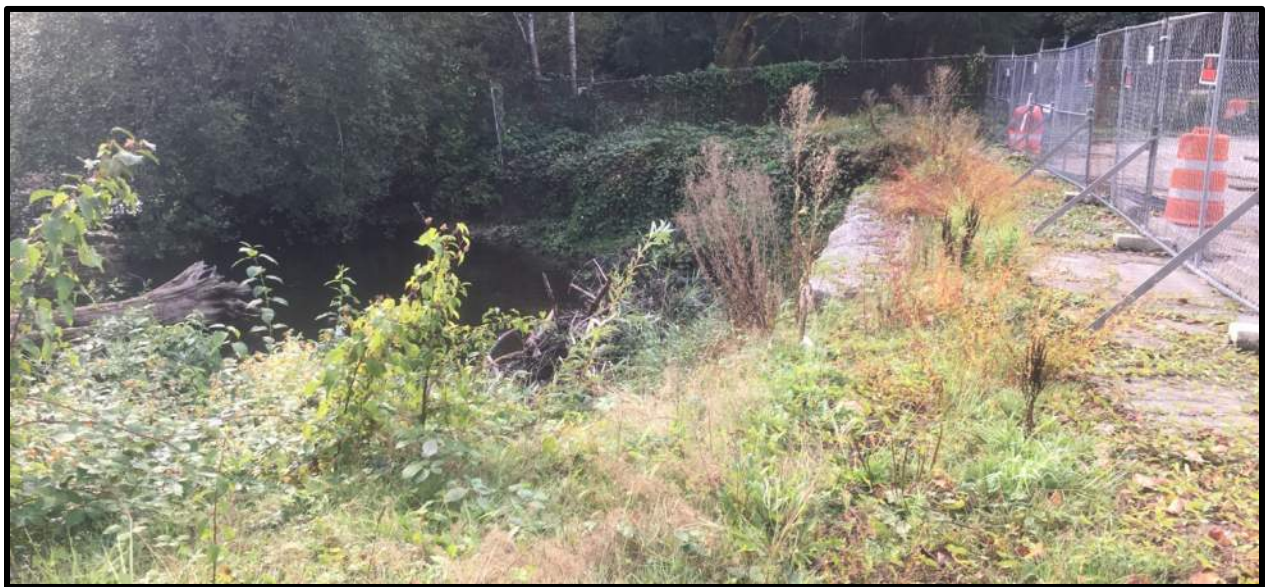
Figure 5 -Temporary stabilization measures, October 2021.

Temporary stabilization measures are currently in place and consist of steel sheets and cobble-filled super sacks installed above the OHWM of Issaquah Creek. Vegetation within the stream buffer in this area consists of English ivy, Himalayan blackberry, thistle, and various grasses.

The temporary measures provide some protection of the aquatic habitat, but they are not adequate for long-term stabilization. The steel plates are not set deep enough to provide protection from scour along the toe of the eroded bank. If no action is taken, further erosion will undermine the existing infrastructure and the temporary stabilization. This will have a negative effect on fish habitat within Issaquah Creek.
